**Fire resistance test for door and shutter assemblies and
openable windows**

TEST REPORT

| Report number: | FPA 106037 r0 |
| Test report on: | One single-leaf, double-acting timber based doorset installed with two BQT Solutions YD30D auxiliary locks, one in the leading edge of the door frame and one in the head of the door frame. |

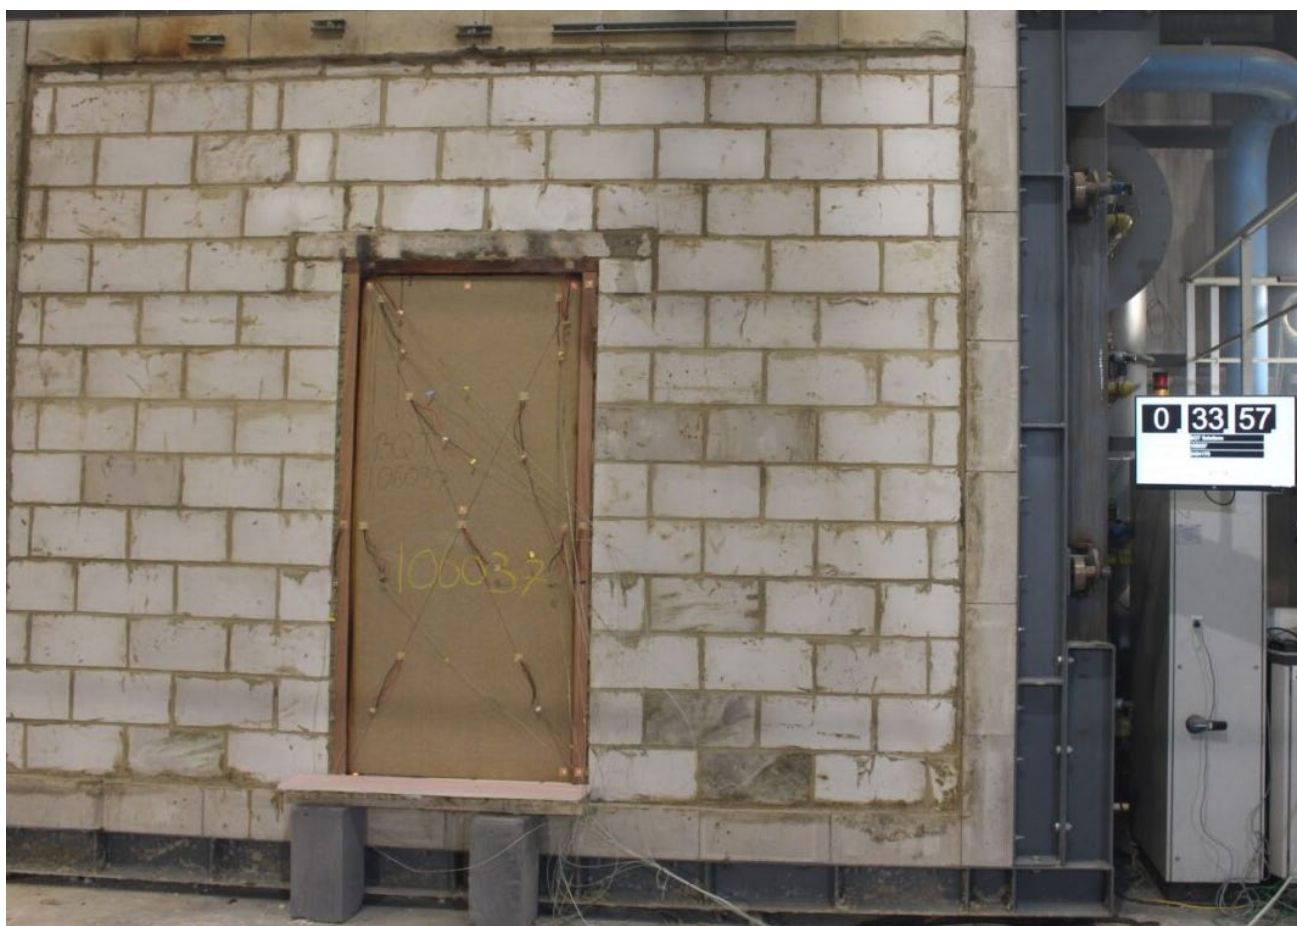
Photo C.6 – Unexposed face at 33:57 test duration.

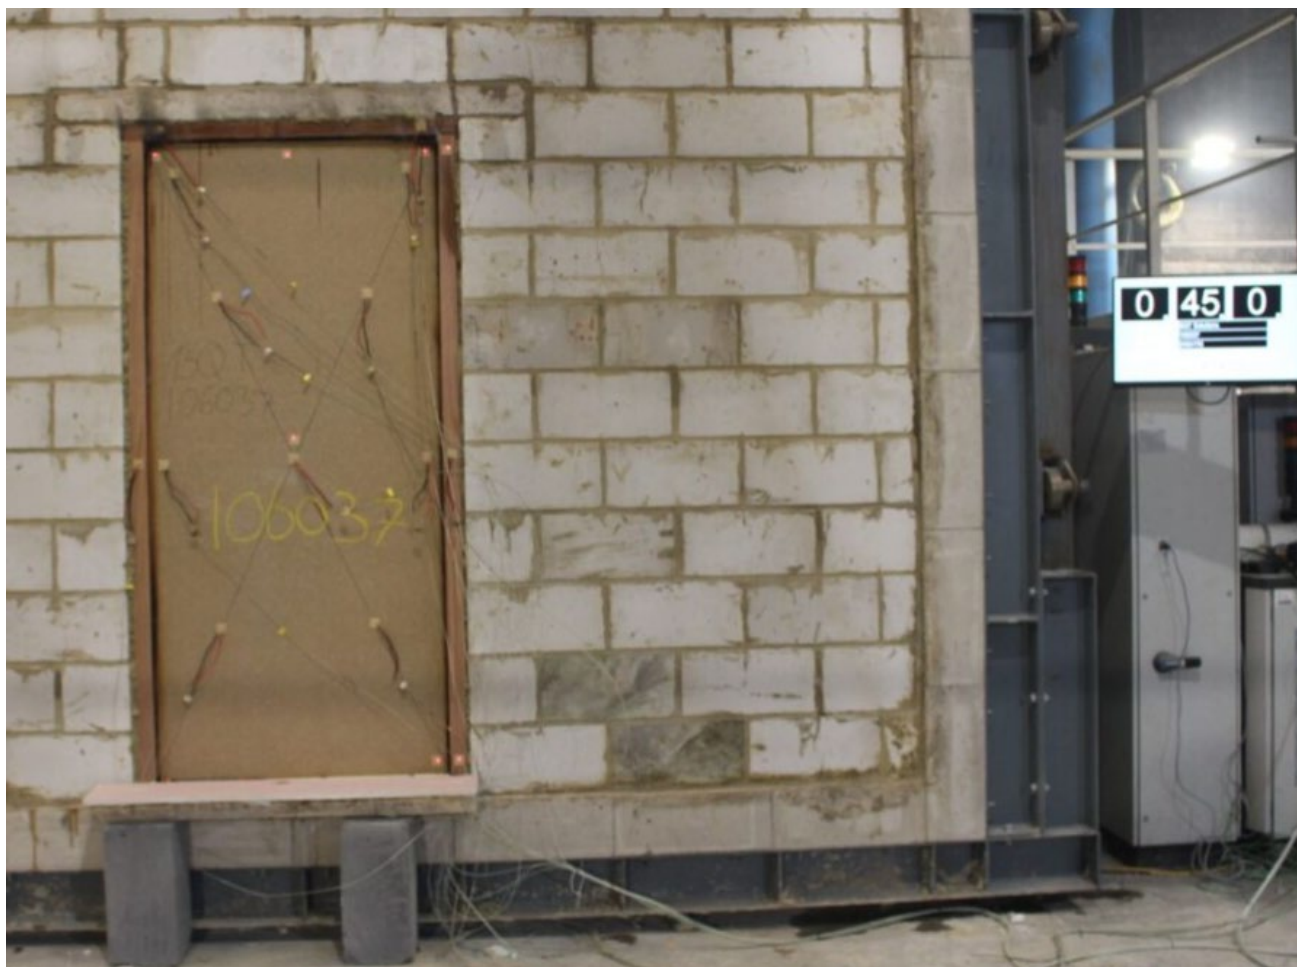
Photo C.7 – Unexposed face at 45 minutes test duration.

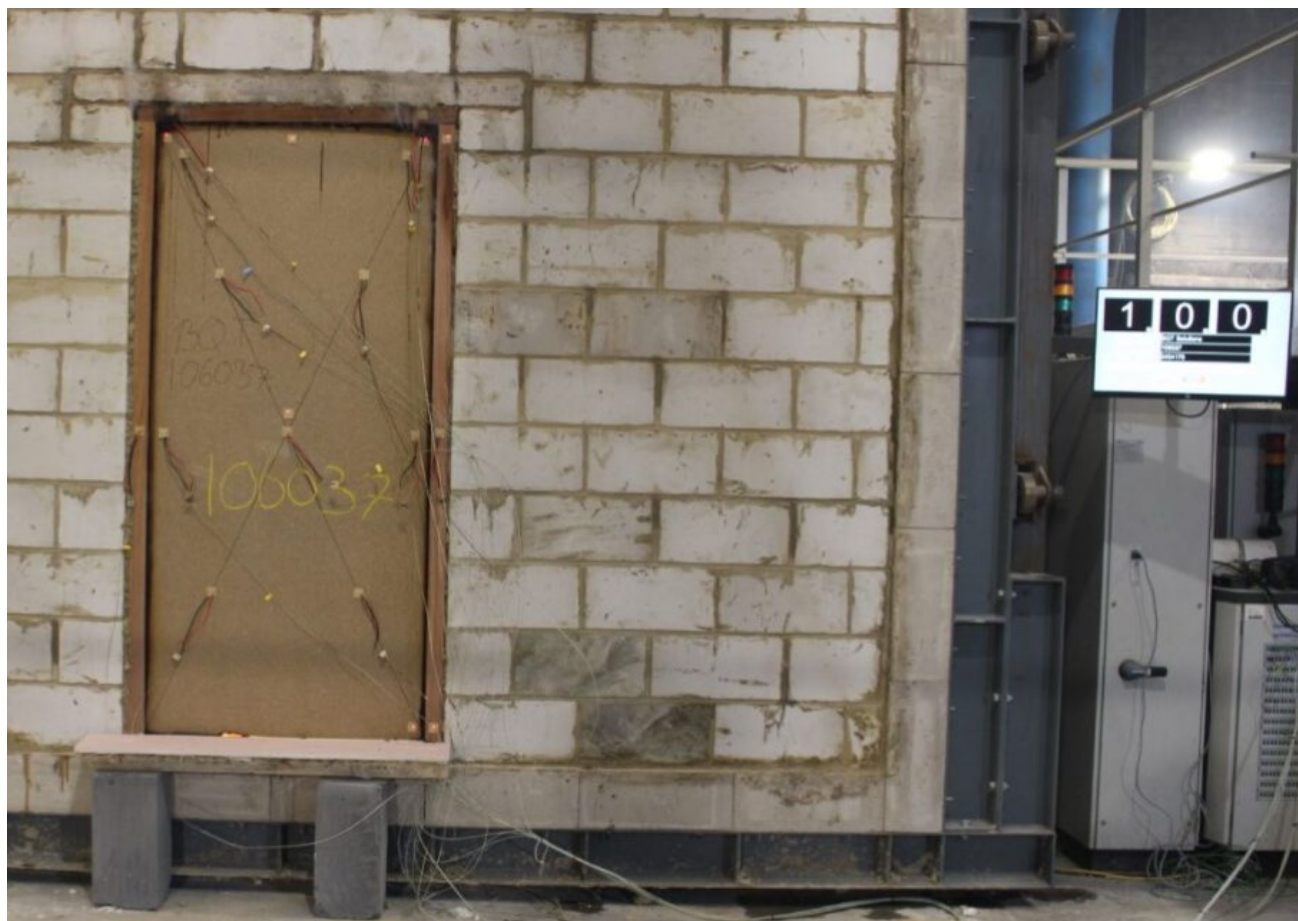
Photo C.8 – Unexposed face at 60 minutes test duration.

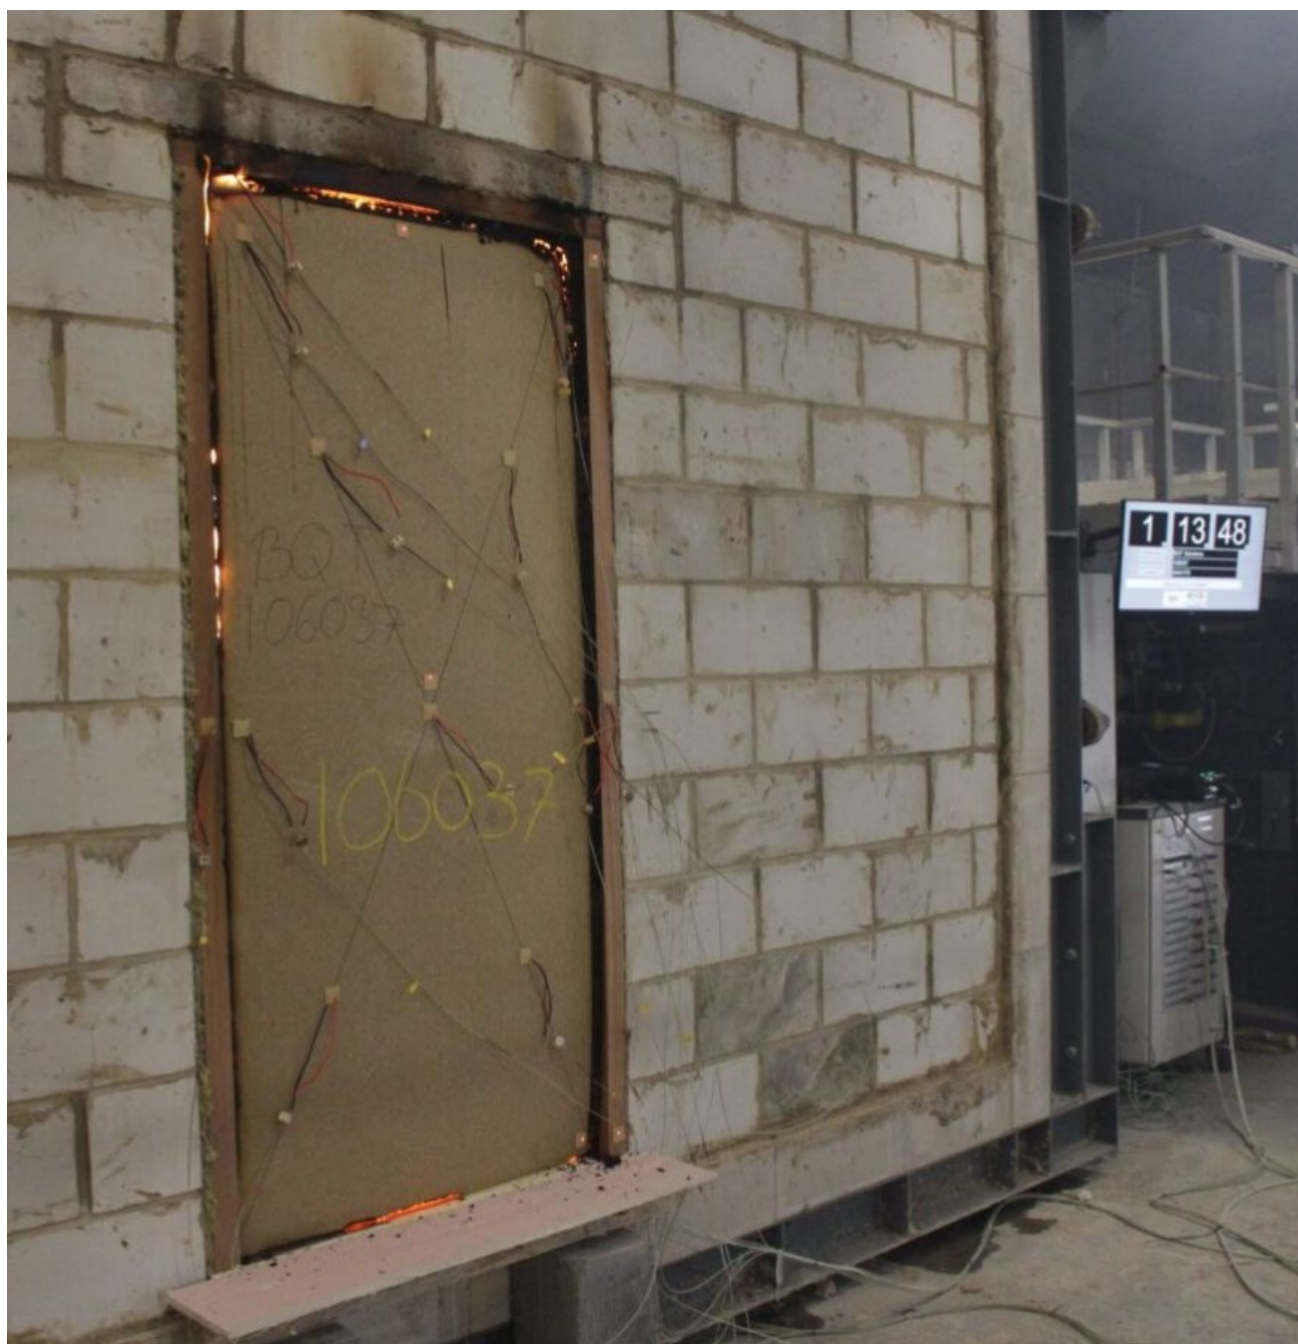
| B.3 – Test Observations | |
|---|---|
| 73:00 | INTEGRITY FAILURE – Cotton pad applied to the head of the leaf at mid-width. Pad flamed immediately after application. |
| 73:10 | FURTHER INTEGRITY FAILURE – Sustained flaming >10s along top edge of door leaf. |

Photo C.9 – Unexposed face after test termination.

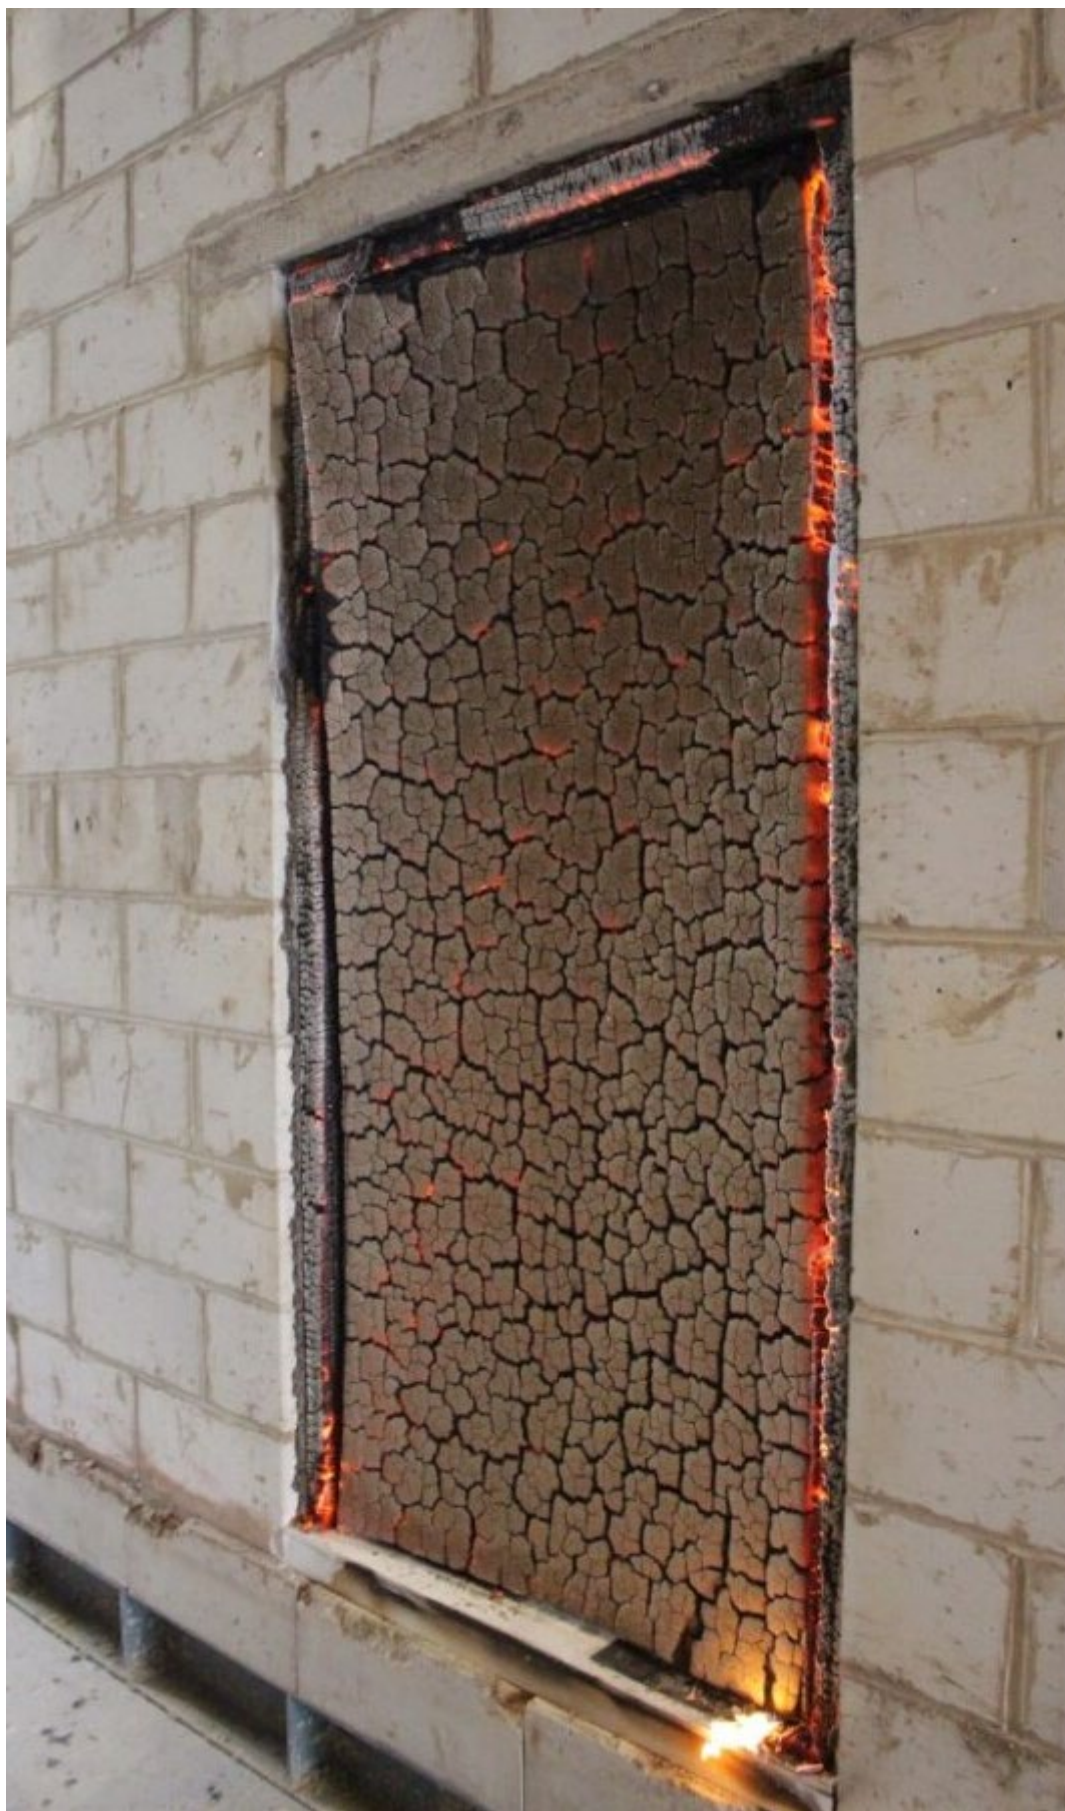
| B.3 – Test Observations | |
|---|---|
| 54:00 | Erosion of door leaf at threshold visible. |

Photo C.10 – Exposed face after test termination.
