# BS EN 1634-1

**Fire resistance test for door and shutter assemblies and  
openable windows**

# TEST REPORT

Report number:	FPA 104947 r0
Test date:	9/10/2023
Test report on:	2 no. timber based door-sets, both single-leaf, double-acting, one 30 minute construction and one 60 minute construction. Each door-set was installed with two BQT Solutions YD30D auxiliary locks in the leading edge and header of the frame.
In accordance with:	BS EN 1634-1:2014+A1:2018
Test sponsor:	<p>BQT Solutions Unit 4, 101 Diana Drive, Wairau Valley, Auckland, 0627, New Zealand</p> <p>This test was conducted by the FPA as service provider to UK Approved Body No. 0843 - UL International(UK) Ltd, 220, Cygnet Court, Centre Park, Warrington, WA1 1PP, United Kingdom, under UL Project No 4790973179.</p>

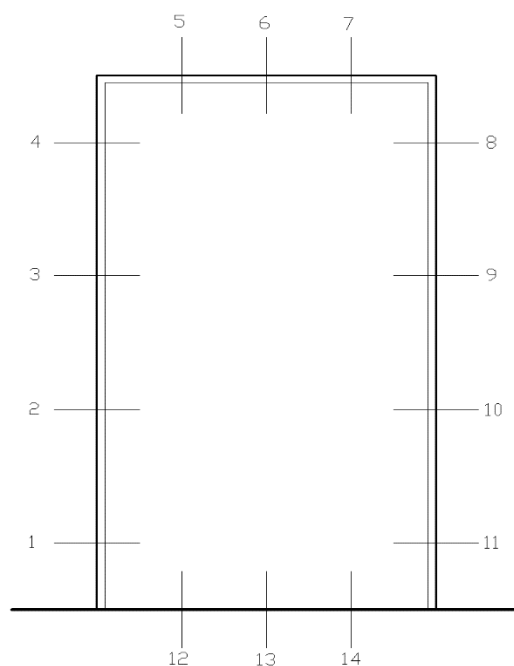
**Figure B.1.5** – Gap Measurements

\*Dimension not included in calculations

Gap Dimension in mm at primary (P) position											
1	2	3	4	5	6	7	8	9	10	11	12*
3.4	6.0	5	3.1	4.3	4.3	4.8	4.8	5.7	5.7	5	4
13*	14*										
4.4	3.5										
Mean		4.7		Maximum		6.0		Minimum		3.1

The maximum size of the primary gaps is shown in Annex A, Illustration A1 – Door Gaps.

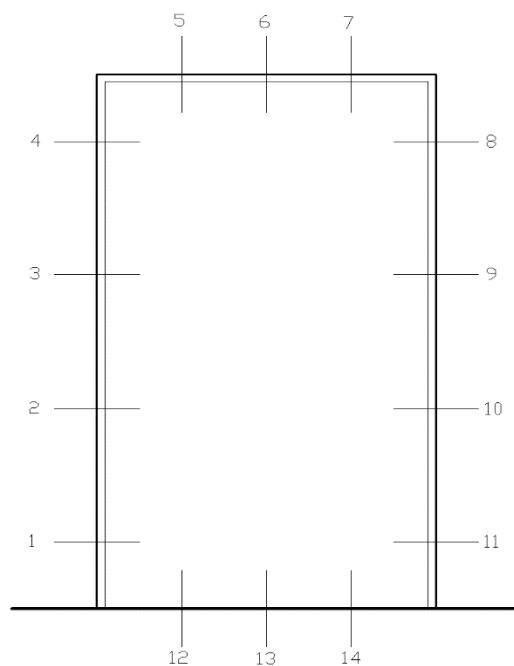
**Figure B.2.5** – Gap Measurements

Gap Dimension in mm at primary (P) position											
1	2	3	4	5	6	7	8	9	10	11	12*
4.8	5.7	5.8	5.9	3.8	3.8	4.5	4.4	3.5	4	5.7	3.9
13*	14*										
3.9	2.4										
Mean		4.7mm		Maximum		5.9mm		Minimum		3.5mm

\*Dimension not included in calculations

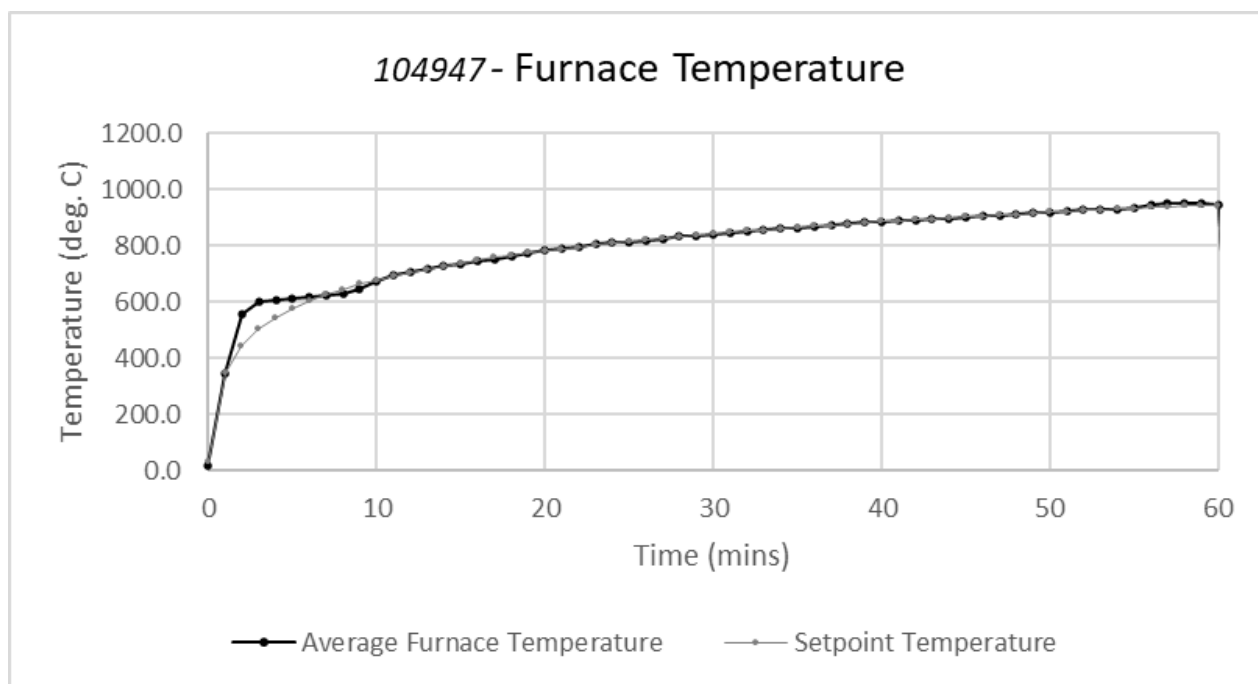
**Figure C.1** – Furnace Temperature

Furnace Temperature - The furnace temperature was measured by twelve EN furnace plate thermometers and controlled to follow the standard heating curve as specified in EN 1363-1.

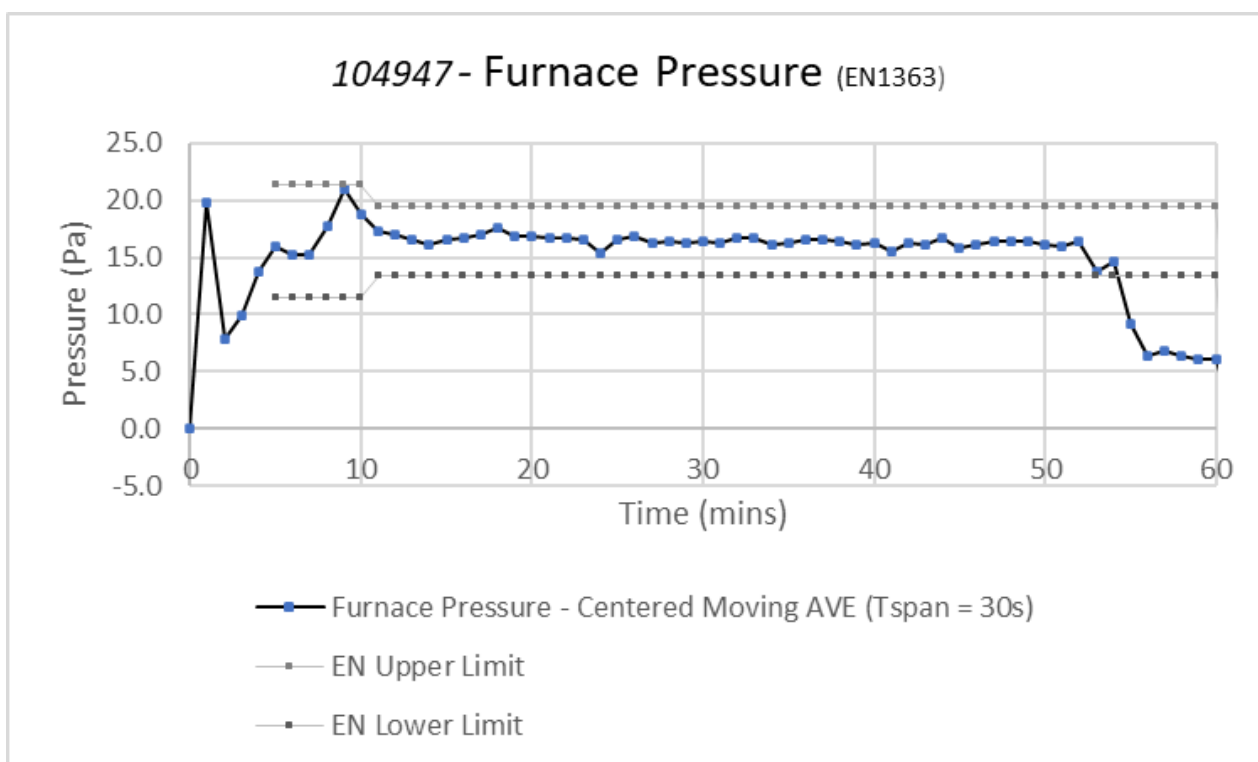
**Figure C.2**– Furnace Pressure

Furnace Pressure - The furnace was set to control to 17 Pa at a height of 2500 mm above the door threshold.

**From 54 minutes test duration onwards (60 minutes), the required furnace pressure could not be maintained (pressure below the limits specified in EN 1634-1). This is a less onerous condition of test. Performance after this time cannot be determined and information is included for reference only.**

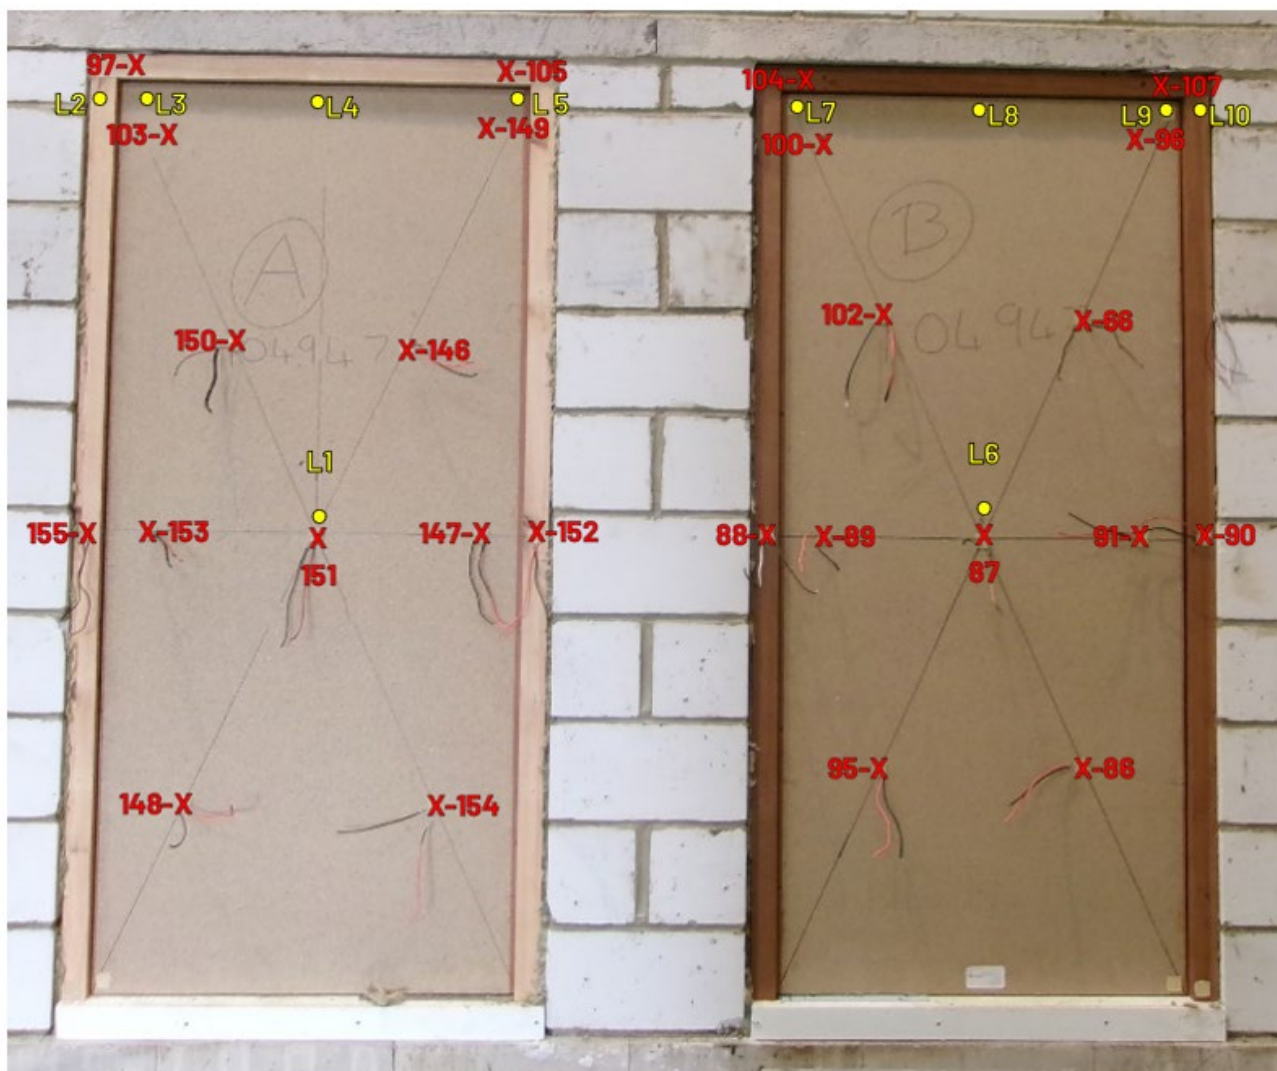
**Figure C.3** – Unexposed surface thermocouple / deflection locations

Insulation Criteria - Unexposed surface thermocouples - Thermocouples were provided to monitor the unexposed surface of the test specimen. The location of the thermocouples is shown in ANNEX B. A roving thermocouple was available for use during the test.

Deflection - A laser array was used to measure the deflection of the specimen at the locations shown in ANNEX B.

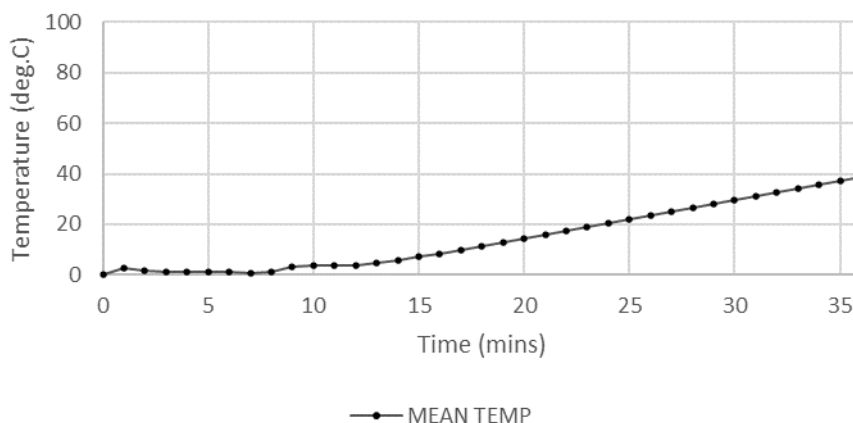
**Figure C.4** – Door-Set A – Unexposed surface temperature rise – Mean – Leaf

### 104947- Unexposed Surface Mean Temperature Rise - Leaf A

<b>Doorset A – Prima 30 minutes Performance Criteria</b>	<b>Performance (Minutes)</b>
<b>INSULATION</b>	
Average temperature, increase of $\Delta 140^{\circ}\text{C}$	36 (test termination)*
Maximum temperature on leaf/leaves, increase of $\Delta 180^{\circ}\text{C}$	36 (test termination)*
Maximum temperature on the frame adjacent to leaf/leaves, increase of $\Delta 360^{\circ}\text{C}$	36 (test termination)*
Maximum temperature on frame(s) not adjacent to leaf/leaves, increase of $\Delta 180^{\circ}\text{C}$	36 (test termination)*
Supplementary Procedure - Average temperature, increase of $\Delta 140^{\circ}\text{C}$	Not evaluated
Supplementary Procedure - Maximum temperature on the leaf, increase of $\Delta 180^{\circ}\text{C}$	Not evaluated
<b>INTEGRITY</b>	
Integrity – Sustained Flaming	36 (test termination)*
Integrity – Ignition of the cotton pad	36 (test termination)*
Integrity – Cracks / openings in excess of given dimensions	36 (test termination)*

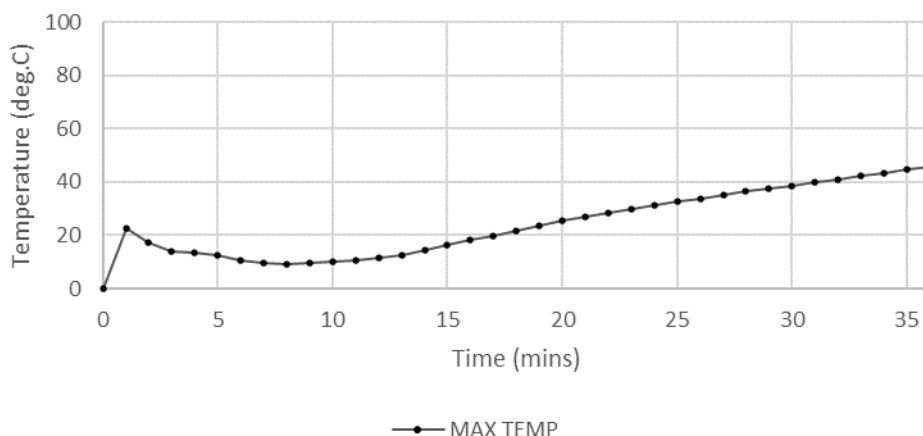
**Figure C.5** – Door-Set A – Unexposed surface temperature rise -Max – Leaf

### 104947- Unexposed Surface Max Temperature Rise - Leaf (A)

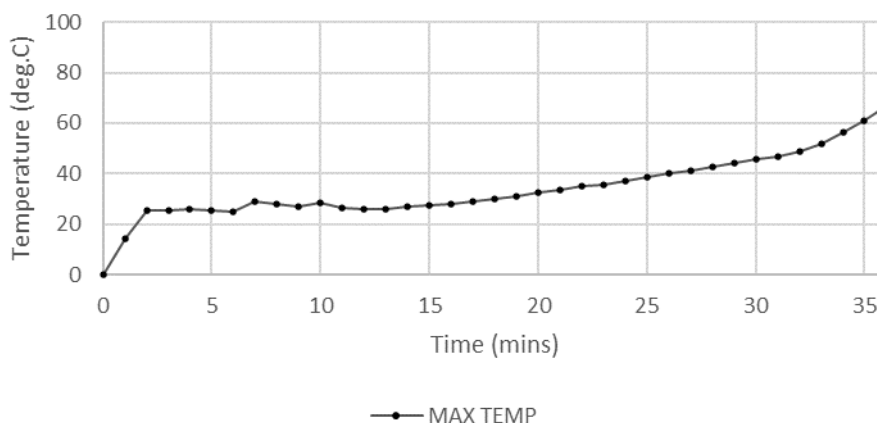
**Figure C.6** – Door-Set A – Unexposed surface temperature rise – Max – Frame

### 104947- Unexposed Surface Max Temperature Rise - Frame (A)

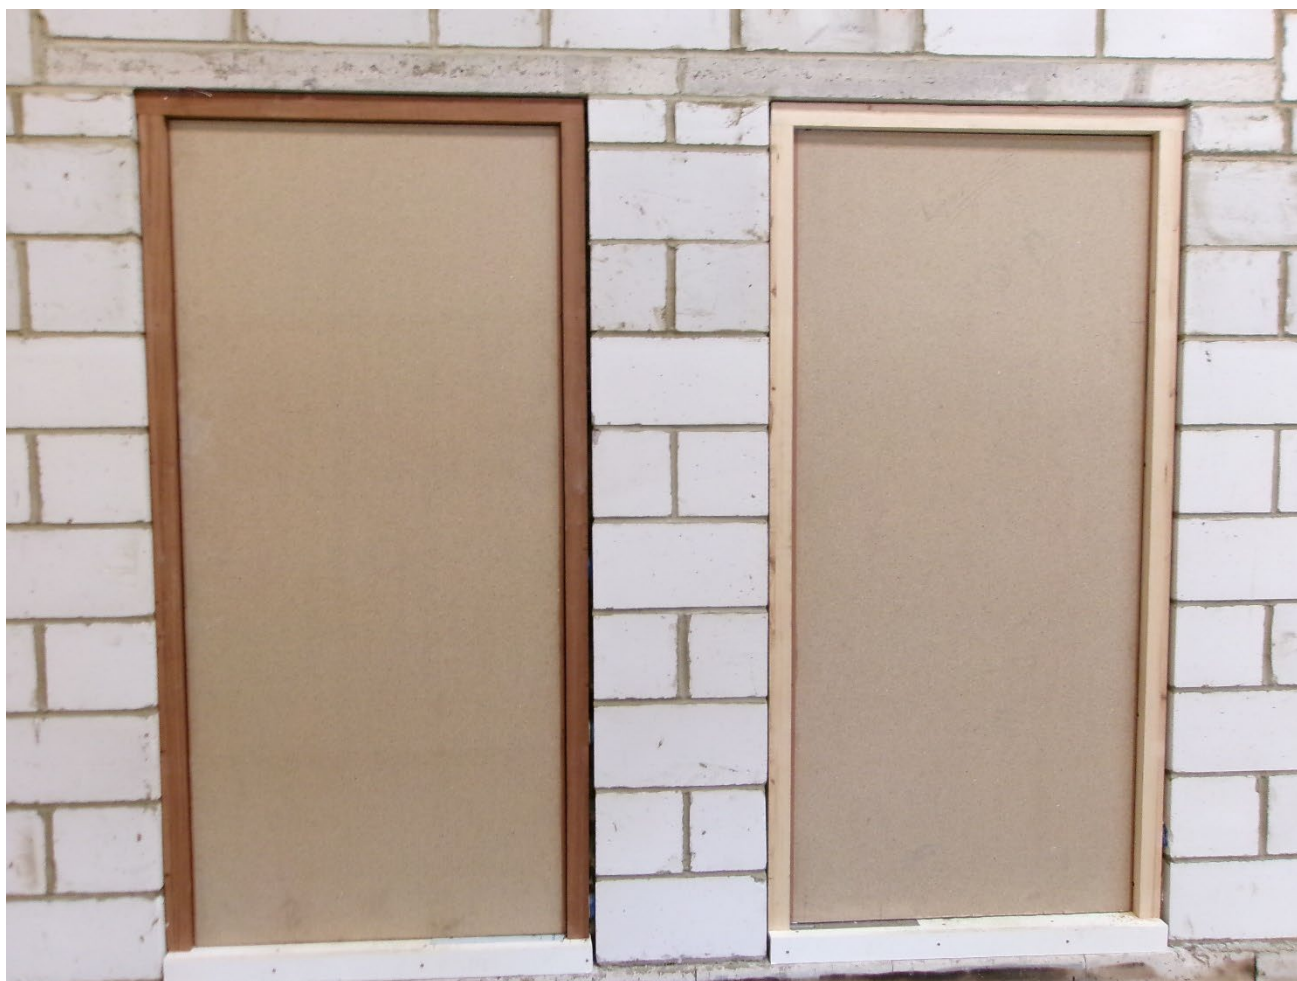
**Figure D.1** – Door-Set A+B – Exposed face Pre-test

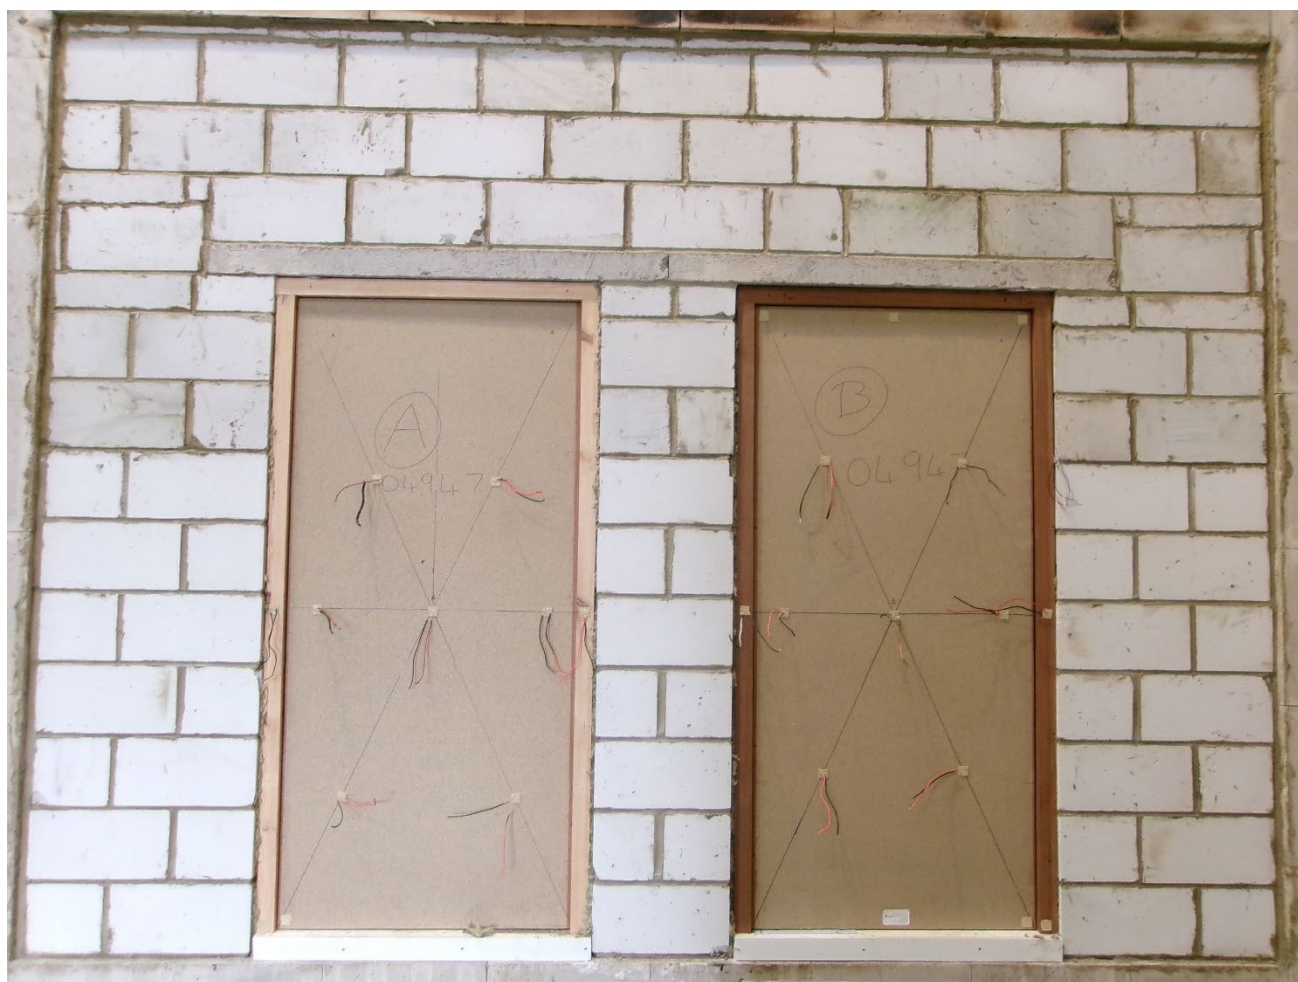
**Figure D.2** – Door-Set A+B – Unexposed Face Pre-test

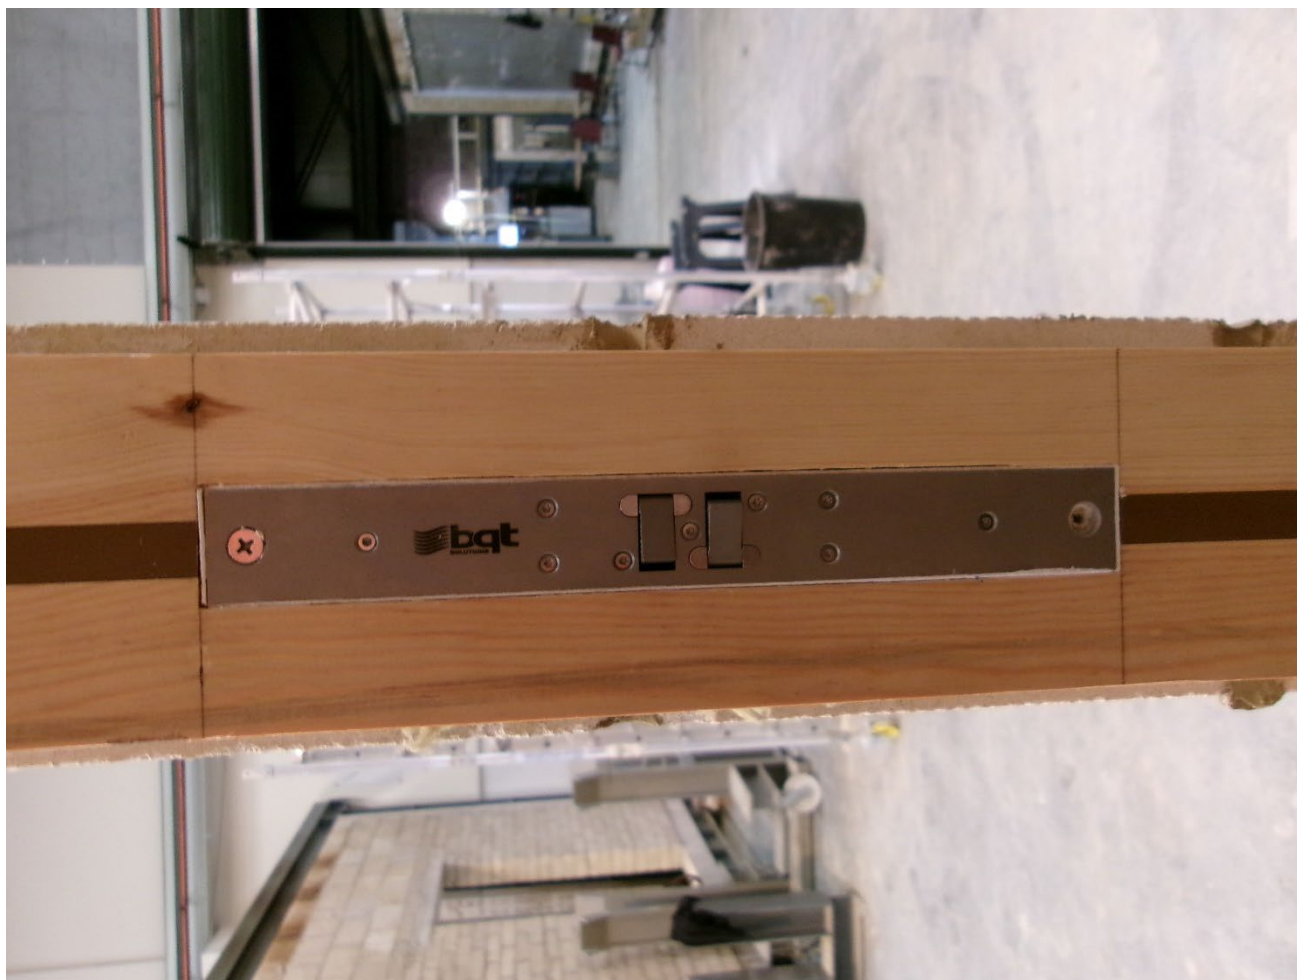
**Figure D.3** – Door-Set A – YD30D Leading edge of Frame Pre-Test.

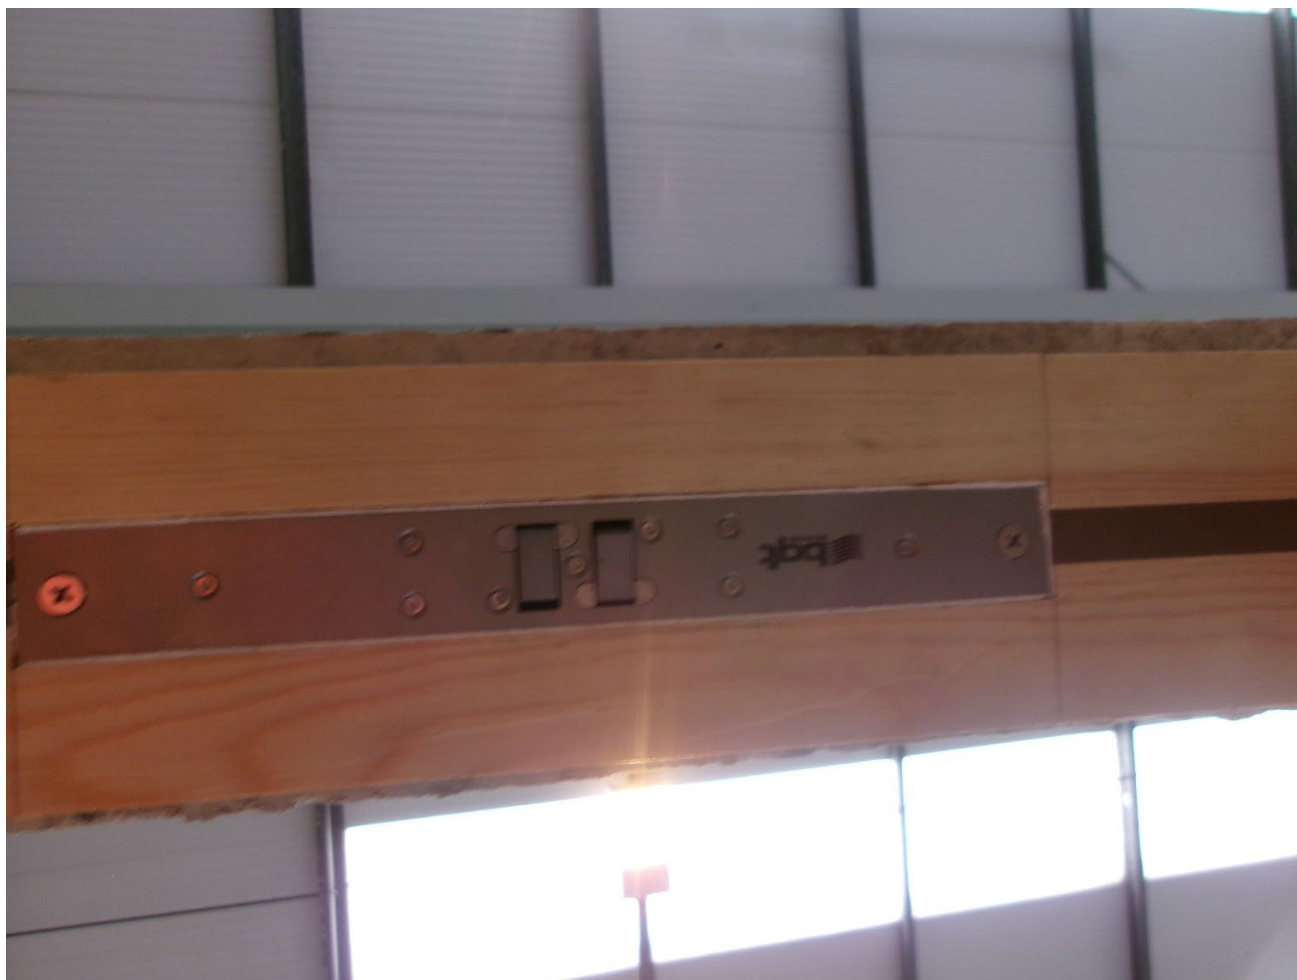
**Figure D.4** – Door-Set A – YD30D Frame Header Pre-Test.

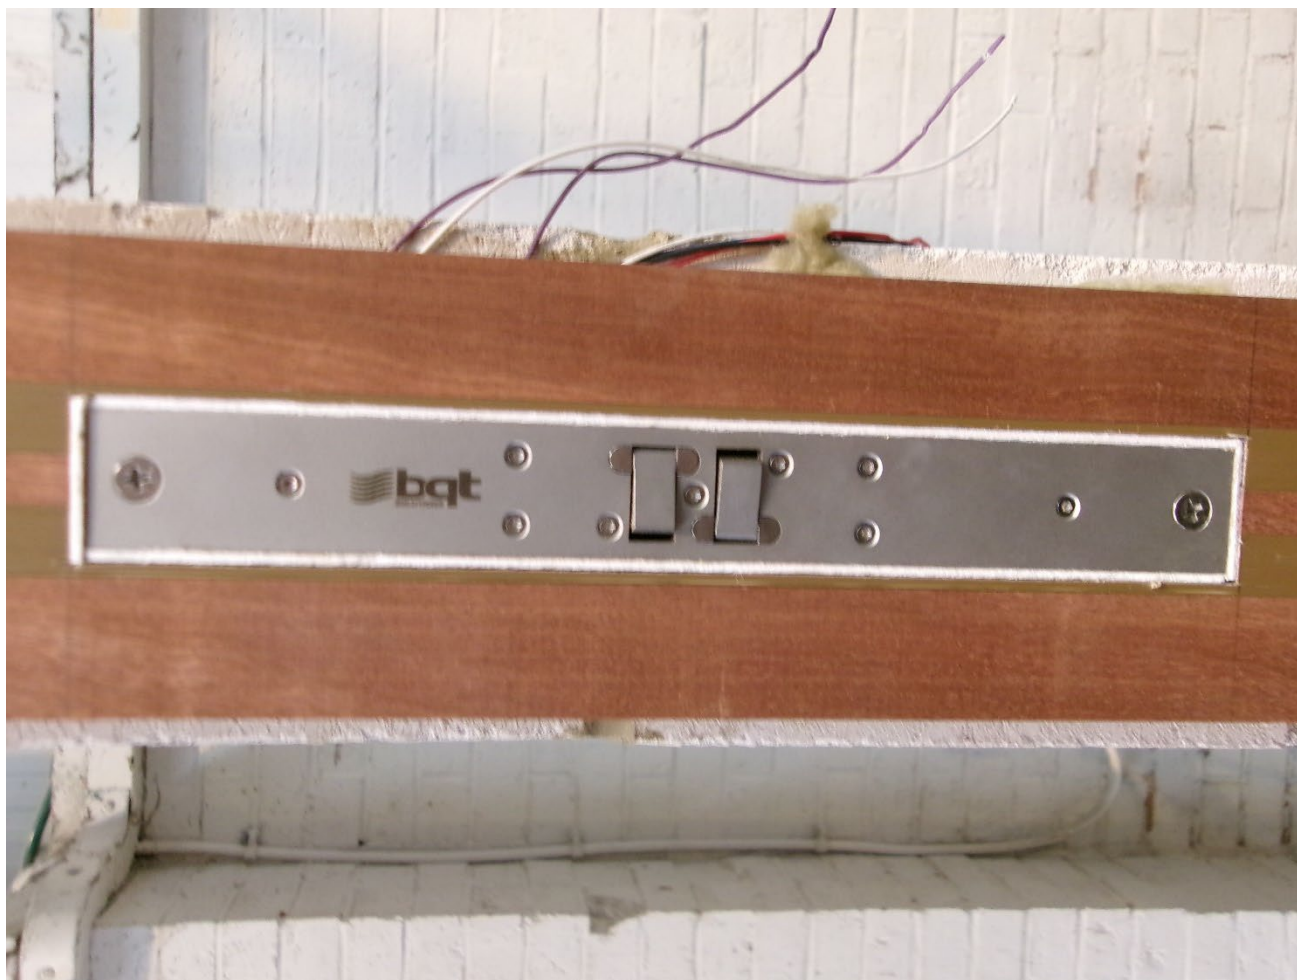
**Figure D.5** – Door-Set B – YD30D Leading edge of Frame Pre-Test.

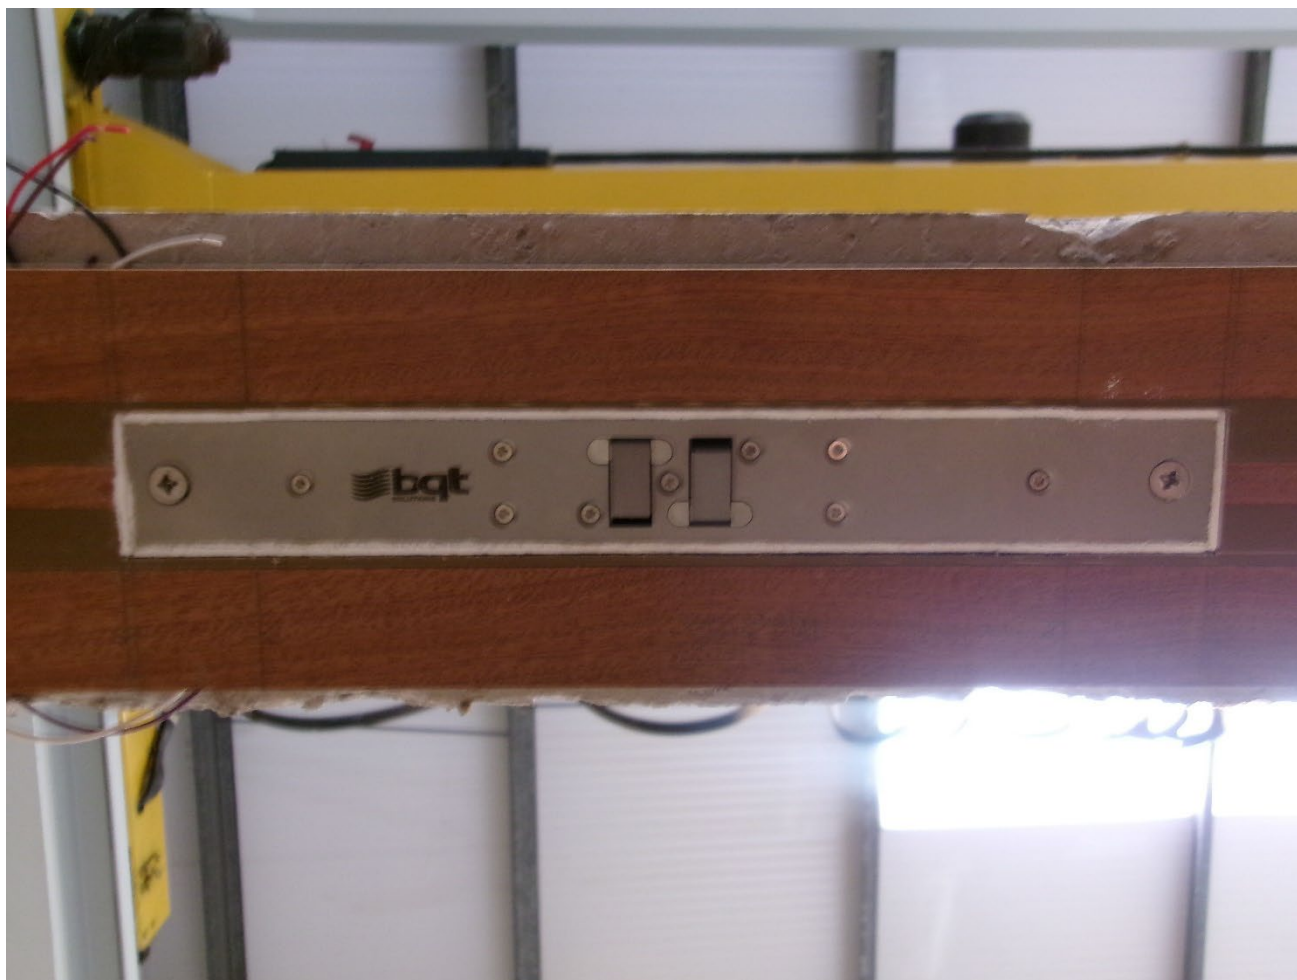
**Figure D.6** – Door-Set B – YD30D Head of Frame Pre-Test.

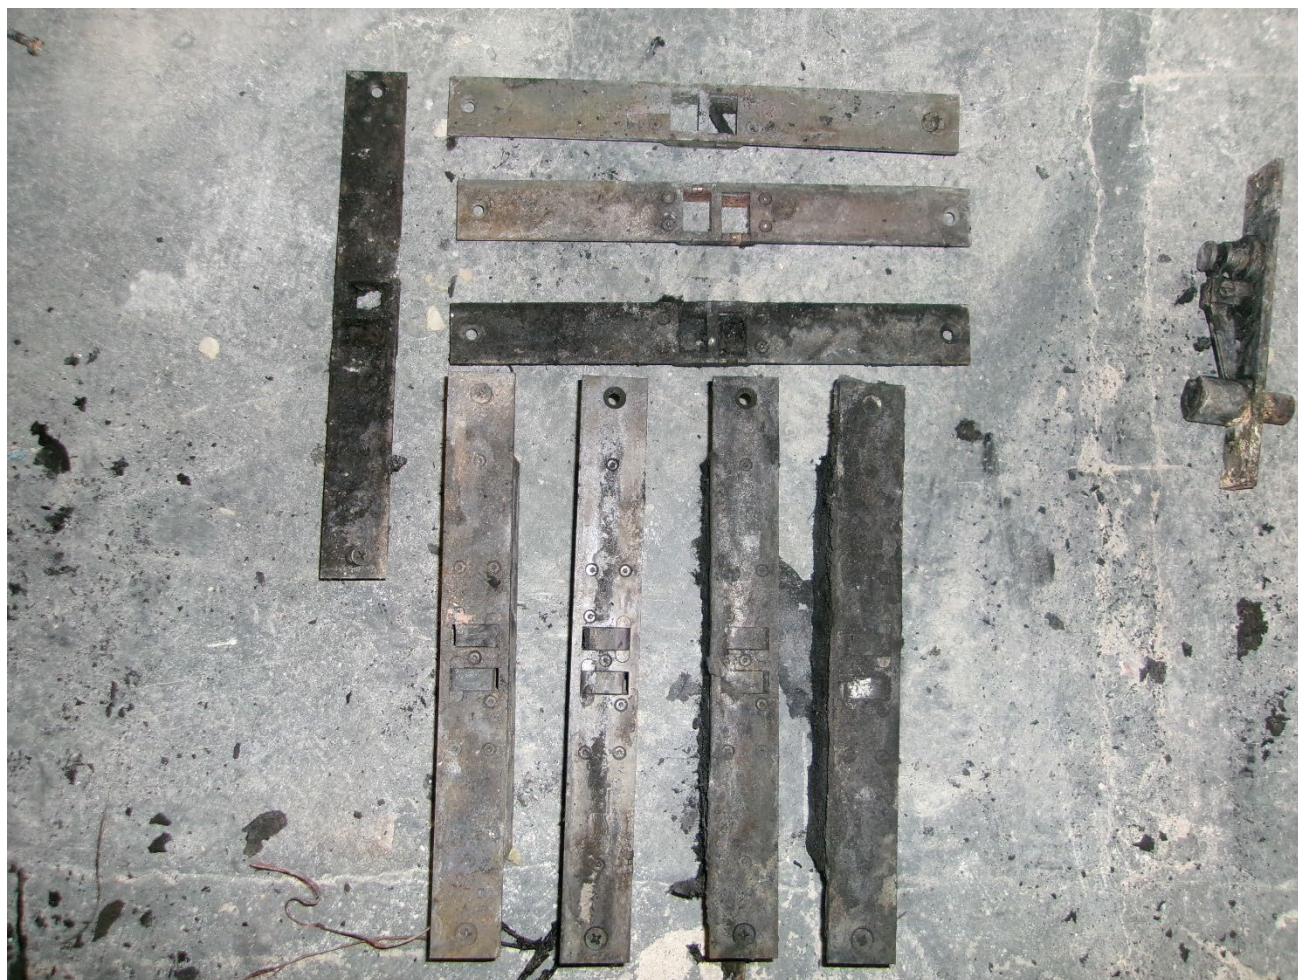
**Figure D.7–** Door-Set Door Set A+B YD30D Post Test 1

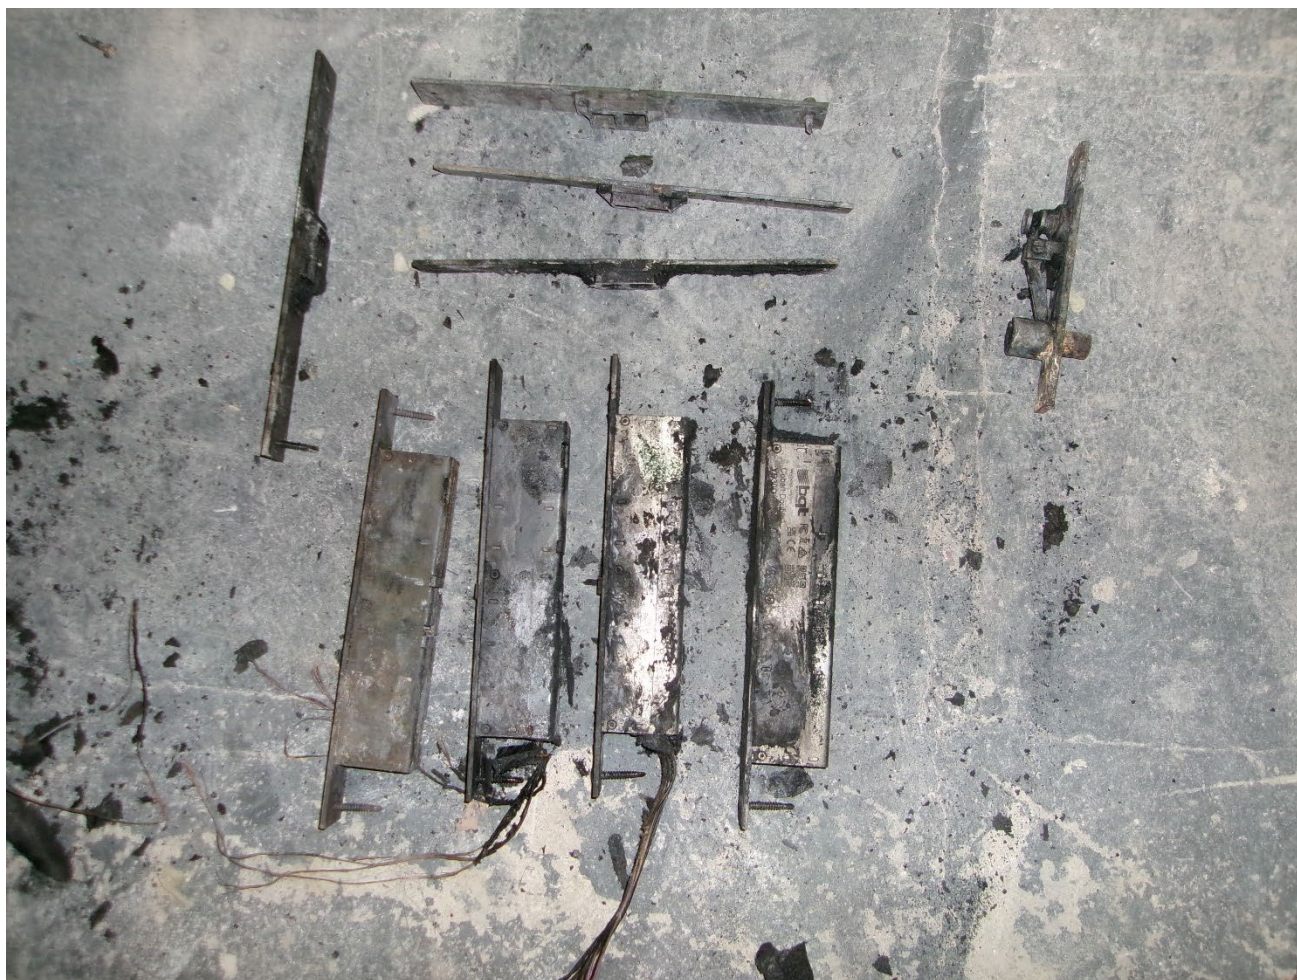
**Figure D.8** – Door-Set Door Set A+B YD30D Post Test 2

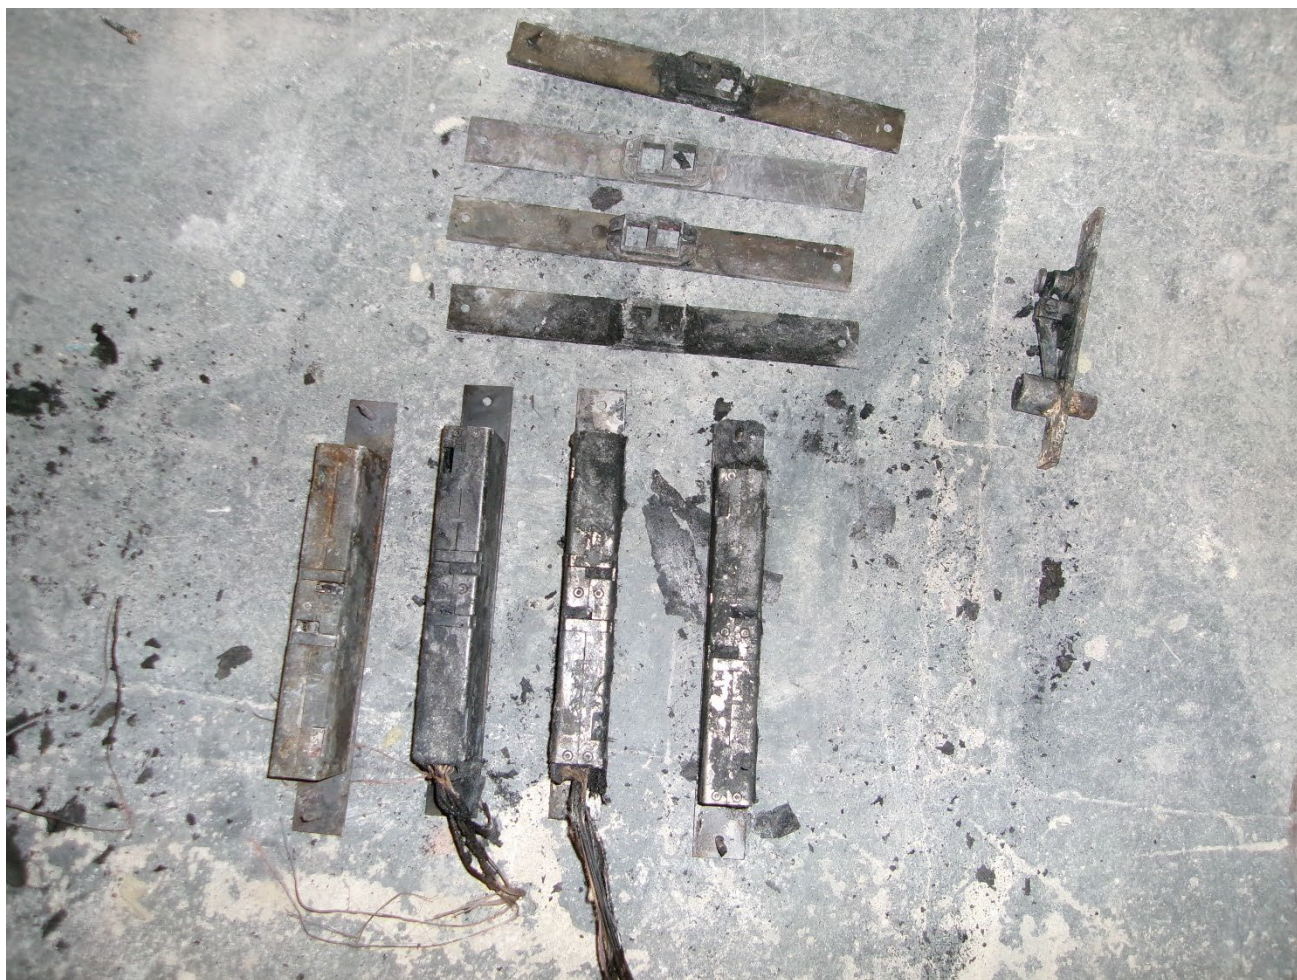
**Figure D.9** – Door-Set Door Set A+B YD30D Post Test 3
