# TEST REPORT

Per your request, project 4788659233 was opened, in accordance with your requested test protocol for the evaluation of product model YG80 performance property. The test was to verify Corrosion test (96h and 240h) for EUT ORCA model YG80.

Sample name..... : ORCA  
Sample model..... : YG80  
Amount of Sample..... : 2 pcs  
Sample Received Date : Sep.20.2018  
Sample Tested Date..... : Sep.20.2018~ Oct.12.2018

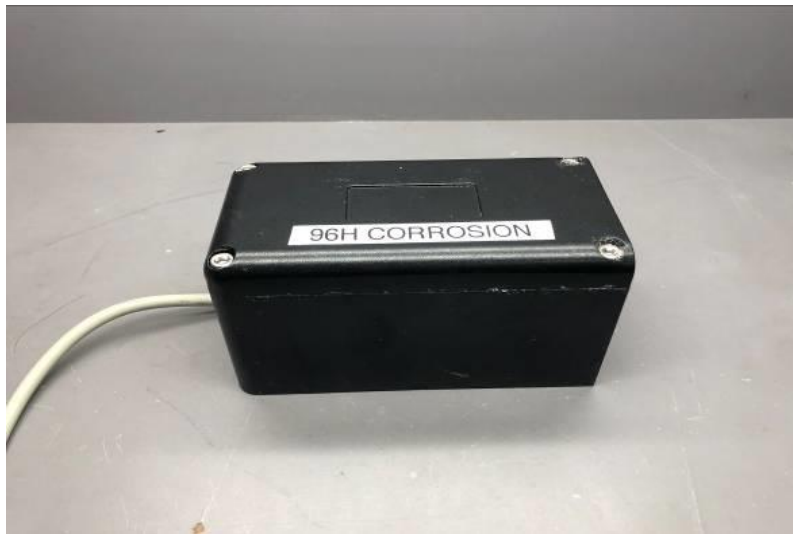
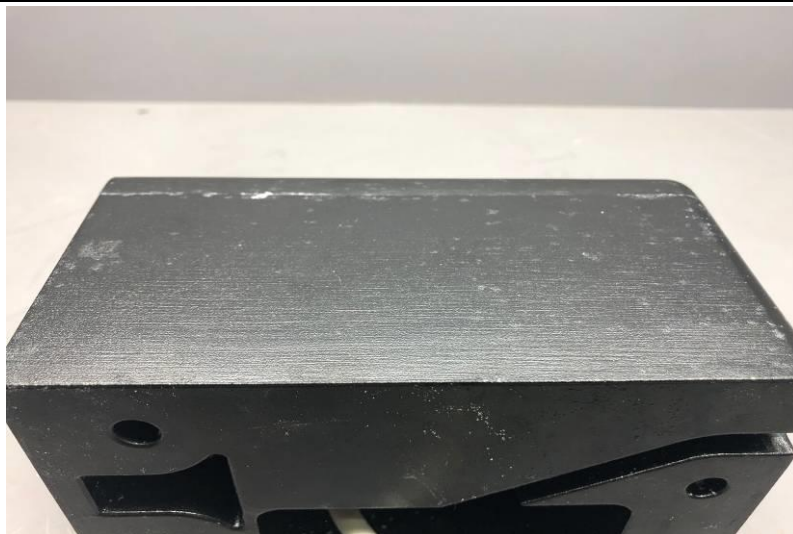
| Sample No. | Test result |
|---|---|
| U180920007 | After test, there is no obvious corrosion phenomenon.<br>There is no obvious exfoliation of the coating. |

Figure 4. The photos of sample U180920007 after test

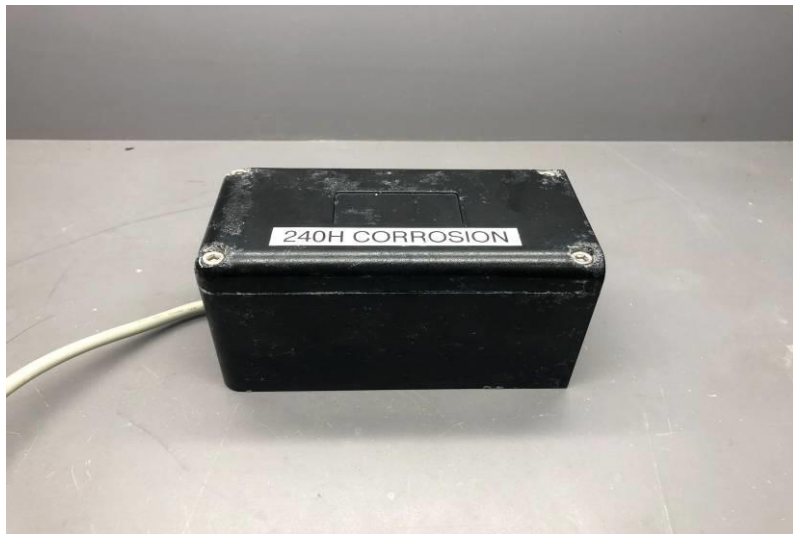
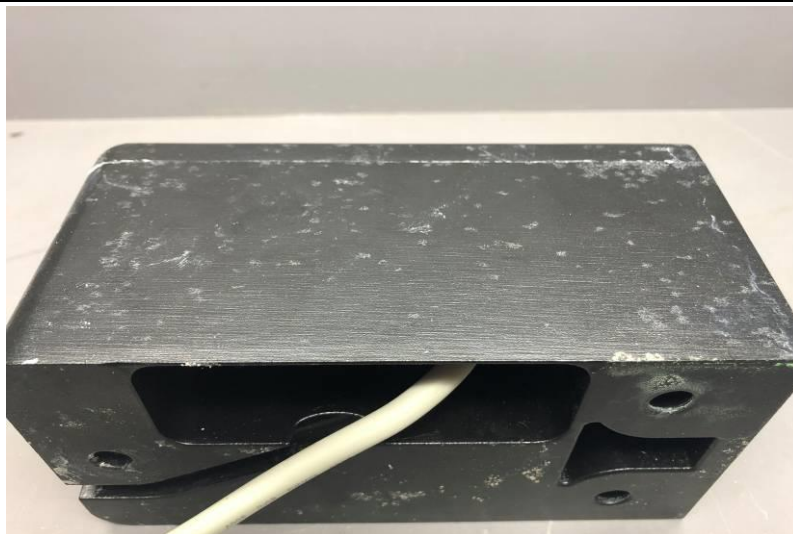
| Sample No. | Test result |
|---|---|
| U180920009 | After test, there is no obvious corrosion phenomenon.<br>There is no obvious exfoliation of the coating. |

Figure 6.The photos of sample U180920008 after test
