Report No.: 4788659233

# TEST REPORT

Per your request, project 4788659233 was opened, in accordance with your requested test protocol for the evaluation of product model YG80 performance property. The test was to verify the IP67 and IPX7 Test for EUT ORCA model YG80.

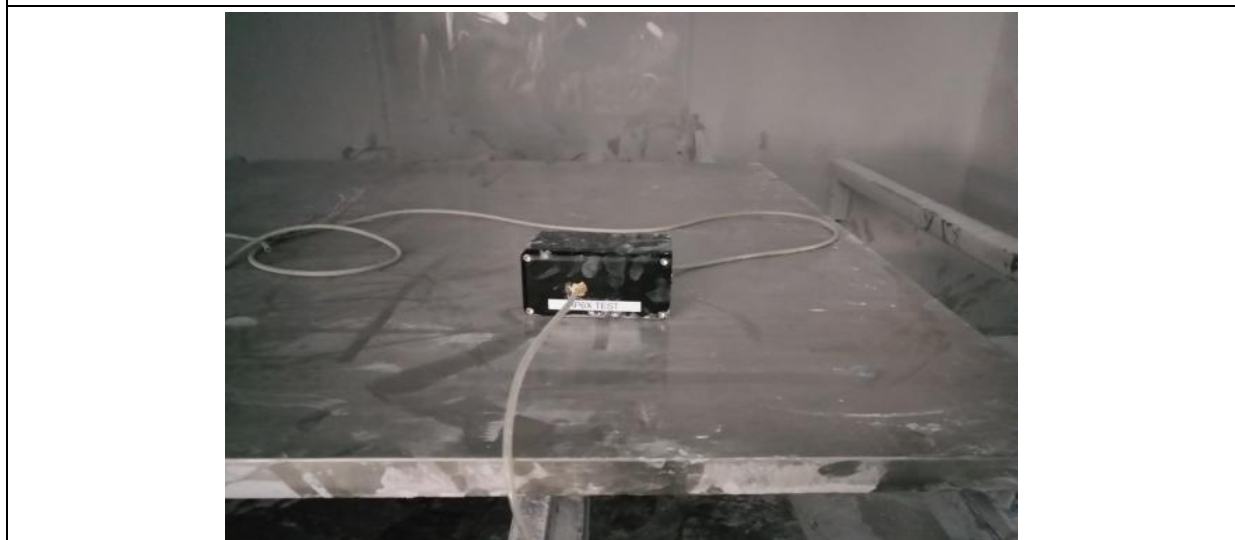
Figure 8.The photo of sample U180920006 during test

The probe diameter: 1mm

Powder categories: talc powder

Density: 2kg/m<sup>3</sup>

Time: 2h

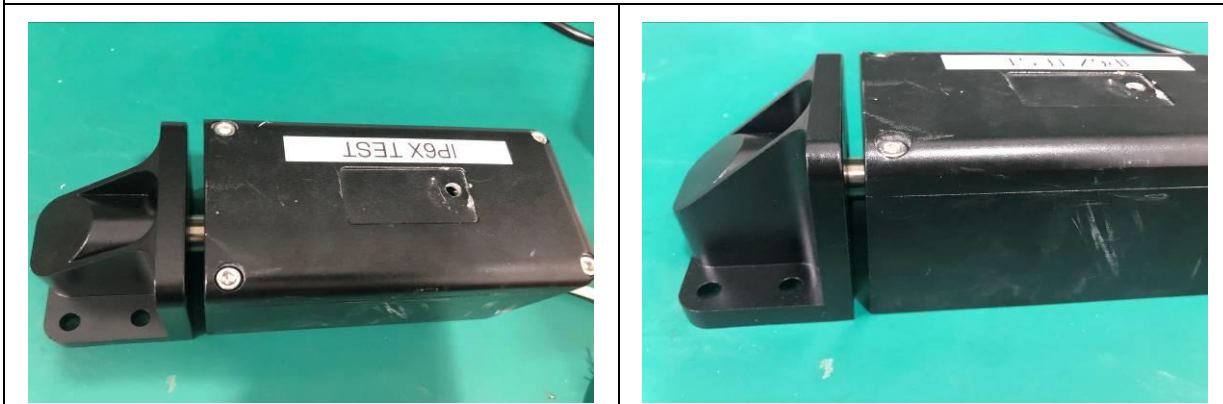
Figure 10.The photos of sample U180920006 functional check after test
