# TEST REPORT

Per your request, project 4788659233 was opened, in accordance with your requested test protocol for the evaluation of product model YG80 performance property. The test was to verify Heat and Cold Test for EUT ORCA model YG80.

Sample name..... : ORCA  
Sample model..... : YG80  
Amount of Sample..... : 2 pcs  
Sample Received Date : Sep.20.2018  
Sample Tested Date..... : Sep.20.2018~ Oct.12.2018

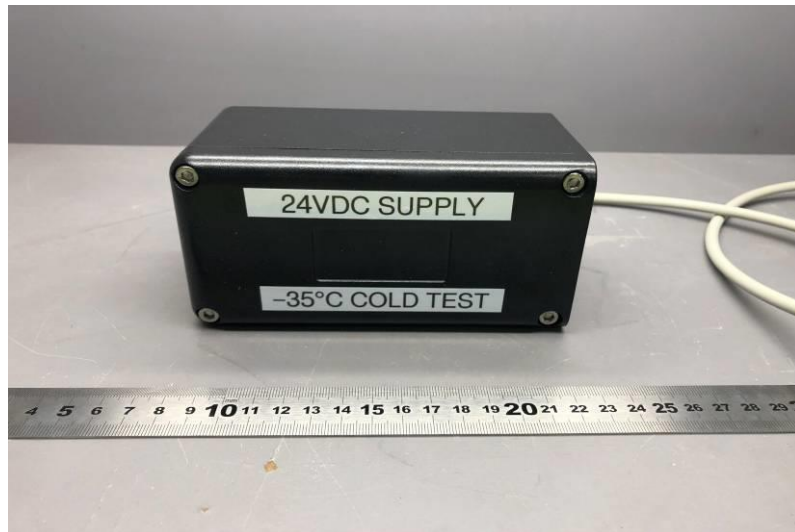
Figure 2.The photos of sample U180920004

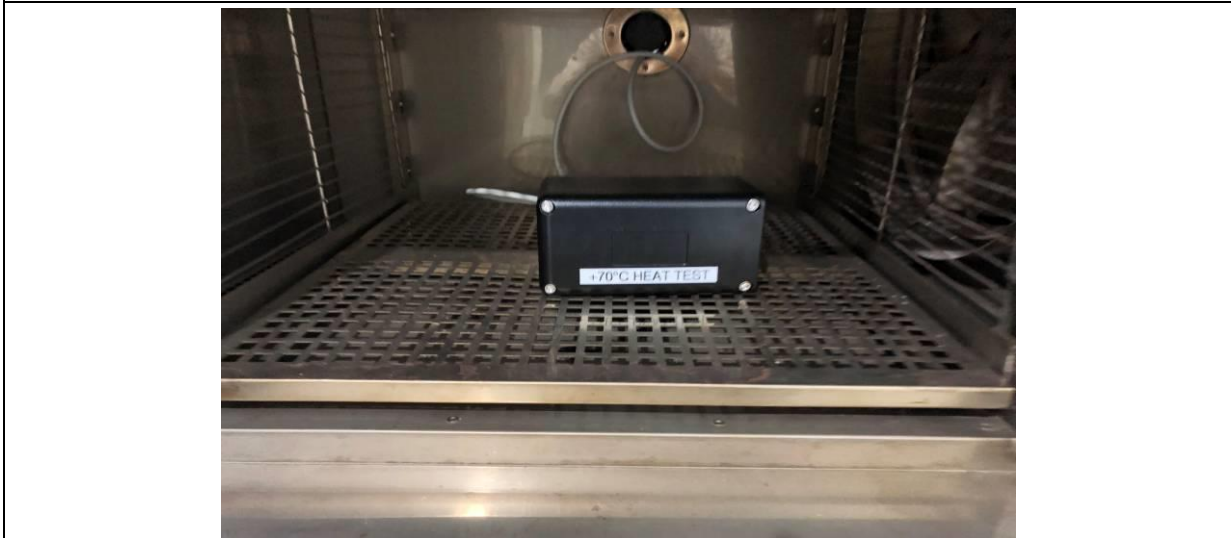
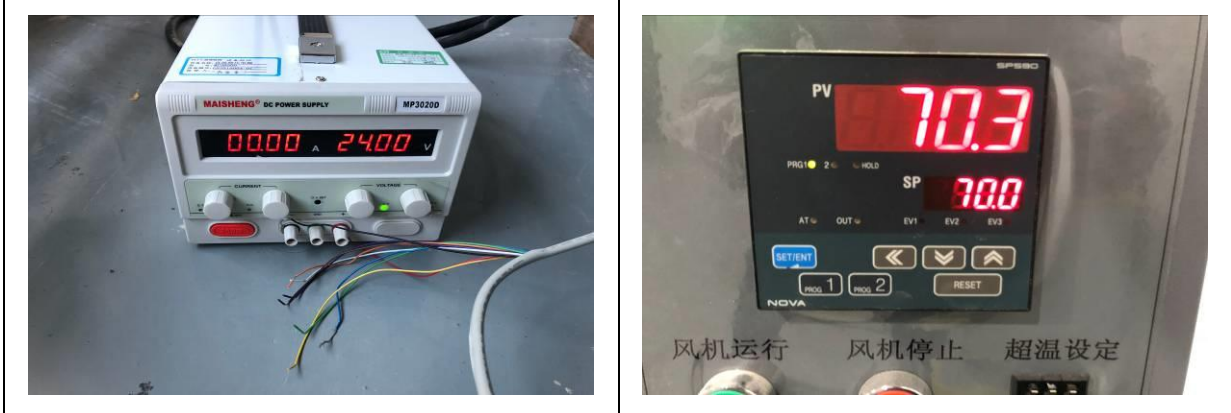
Figure 4.The photos of sample U180920003 during test

Test temperature: 70°C

Time: 2h

24V DC voltage was applied throughout the test.

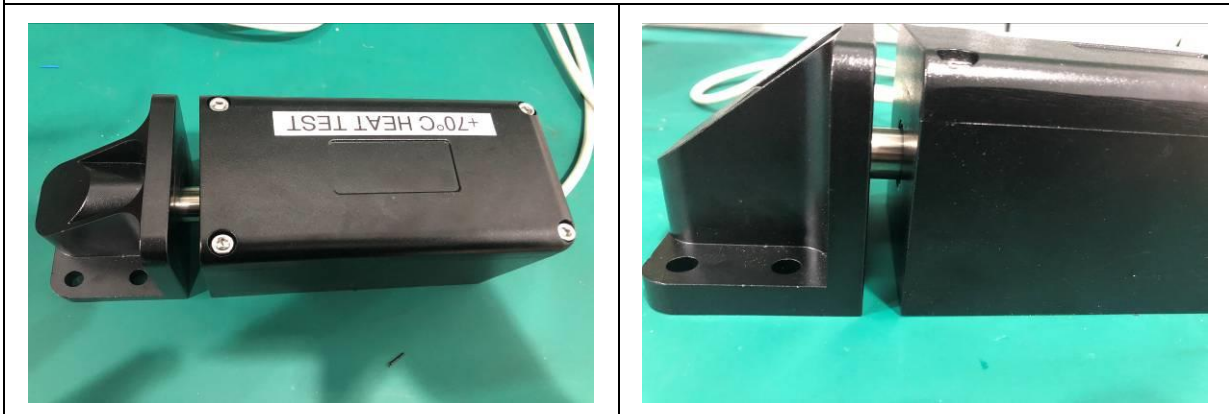
Figure 6.The photos of sample U180920003 functional check after test

| Sample No. | Test result | Test requirement | Judgement |
|---|---|---|---|
| U180920003 | After test, the product's function is normal. | After test, the product's function should be normal. | Pass |

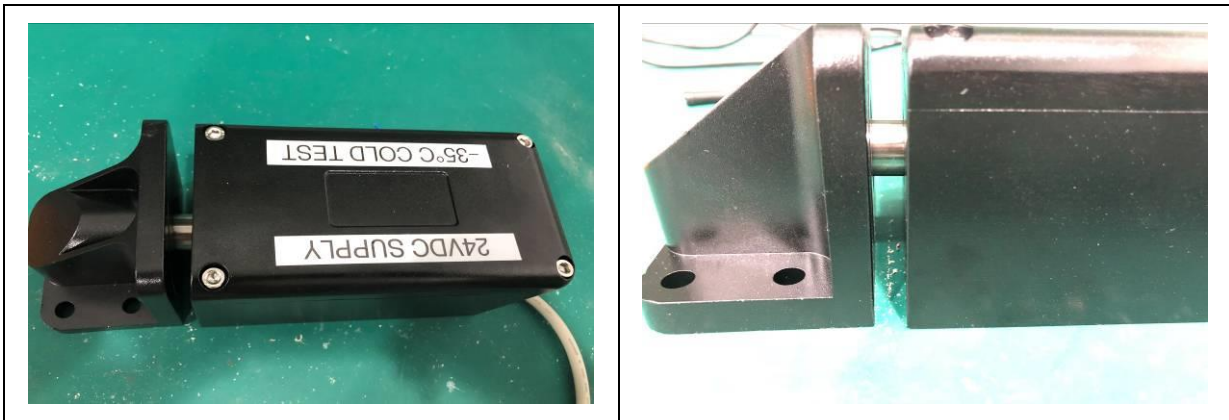
Figure 7.The photos of sample U180920004 functional check before test

Check product functional before and after test.
